CHIEF JOSEPH DAM Columbia River, Washington

ADDITIONAL UNITS AND STRUCTURAL MODIFICATION FOUNDATION REPORT

US Army Corps
of Engineers
Seattle District

12. PERSONAL AUTHOR(S) Richard D. Eckerlin (Geologist) and Edward T. Bailey (Project Geologist)					
13a. TYPE OF REPORT Final Report		13b. TIME COVERED FROM _____ TO _____		14. DATE OF REPORT (Year, Month, Day) 1988

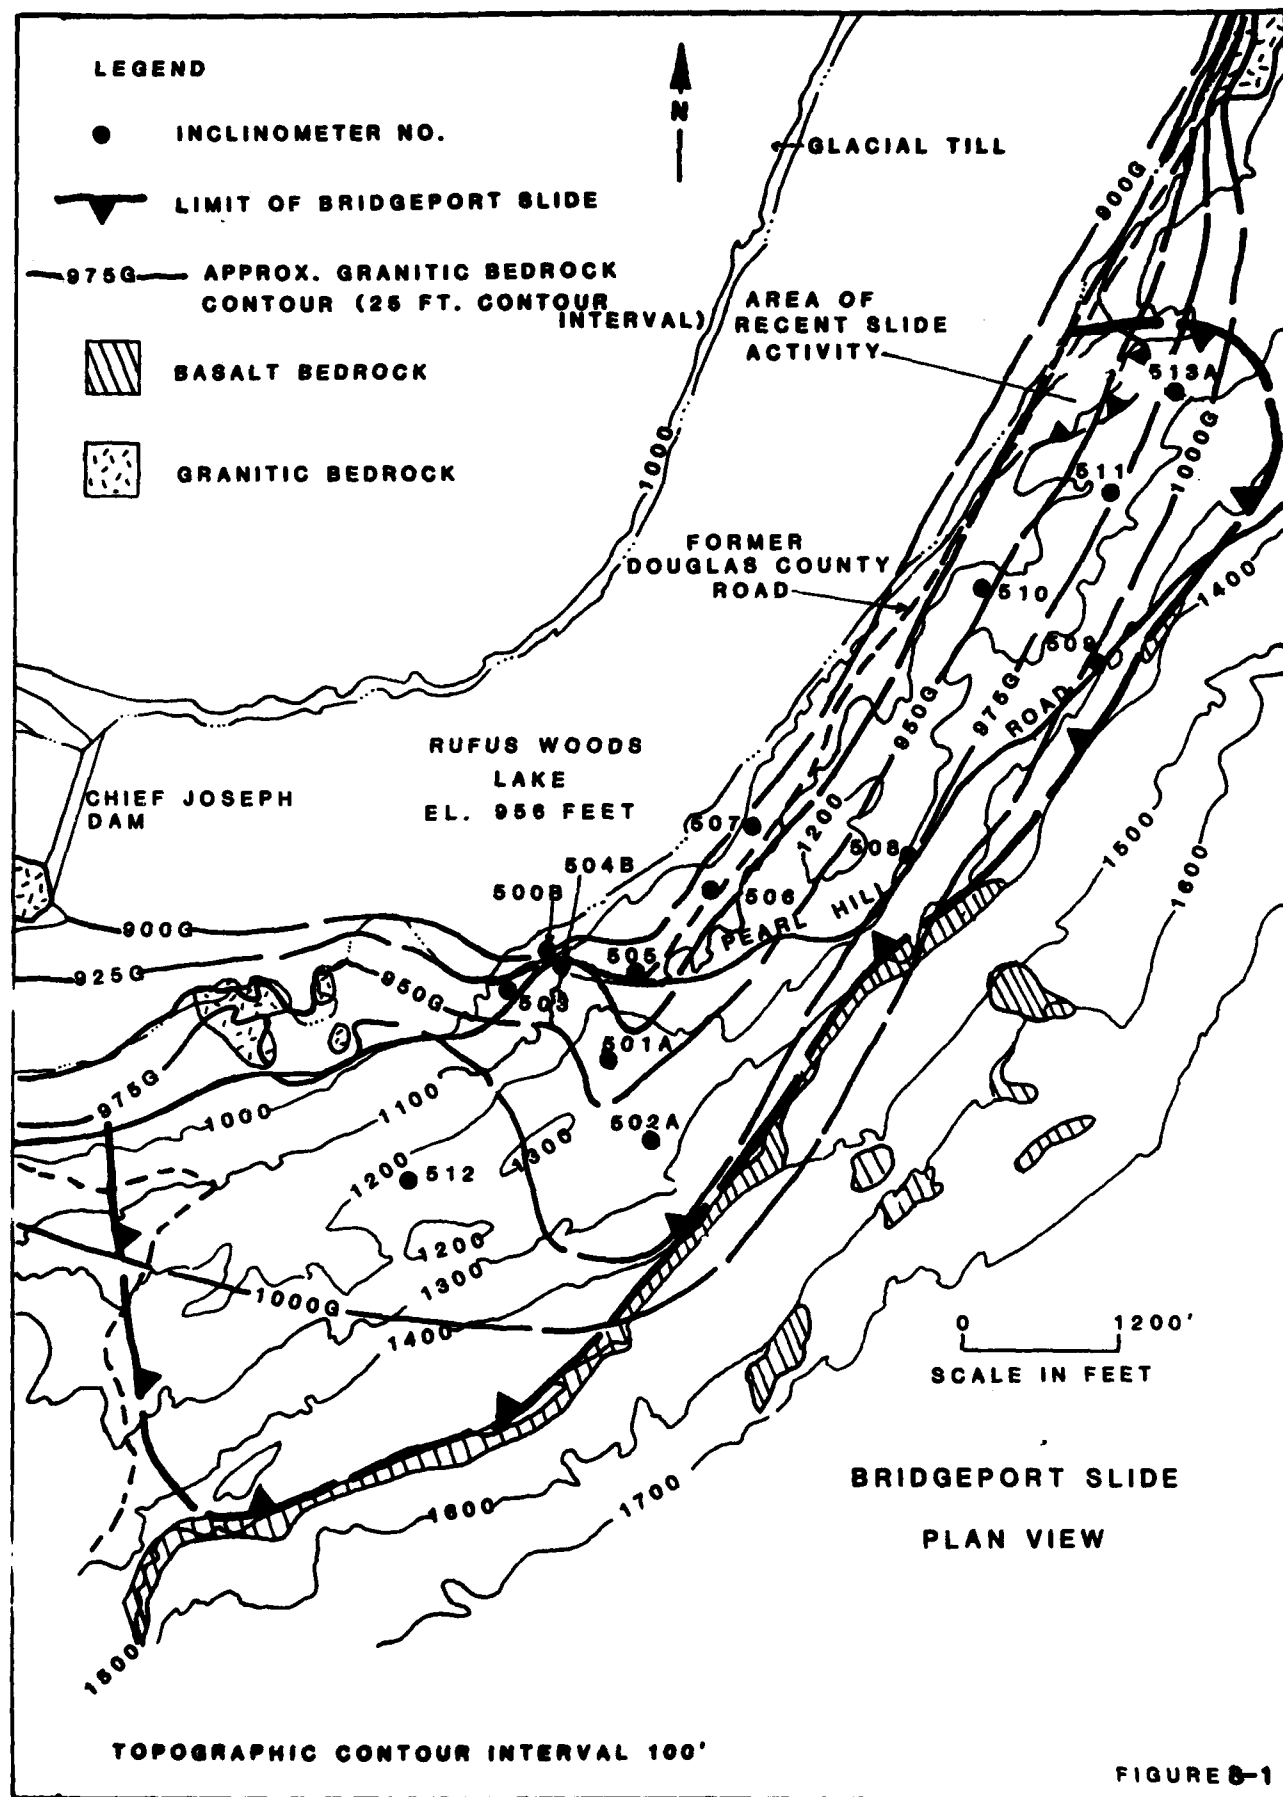
FIGURE 8-1

8.02 Bridgeport Slide. Bridgeport Slide (figure 8-1) is located on the left (south) bank just upstream from Chief Joseph Dam. The status report of the slide is found in Chief Joseph Dam, Periodic Inspection Report No. 8, April 1986. The slide encompasses an area 2.5 miles long by 0.5 mile wide. Initial sliding is prehistoric, but portions of the slide mass are currently being affected by the reservoir. Slide movement near the upstream end of the Bridgeport Slide required abandonment and relocation of a portion of Douglas County Road 321 during the 1970's. Easements, which restrict land use around the reservoir periphery, have been obtained. Such easements include existing landslides adjacent to the reservoir and areas subject to erosion by the reservoir. Recent fresh cracking of the ground surface is visible several hundred feet upslope from the abandoned road. The slide is monitored using photogrammetric methods at least twice annually and inclinometers are measured approximately four times per year. The Bridgeport Slide poses no apparent direct threat to the dam.
